Outfall Survey

Mimico Creek
Municipality of Metropolitan Toronto

REPORT ON
AN OUTFALL SURVEY
OF
MIMICO CREEK
WITHIN
THE MUNICIPALITY OF METROPOLITAN TORONTO

FEBRUARY , 1973.

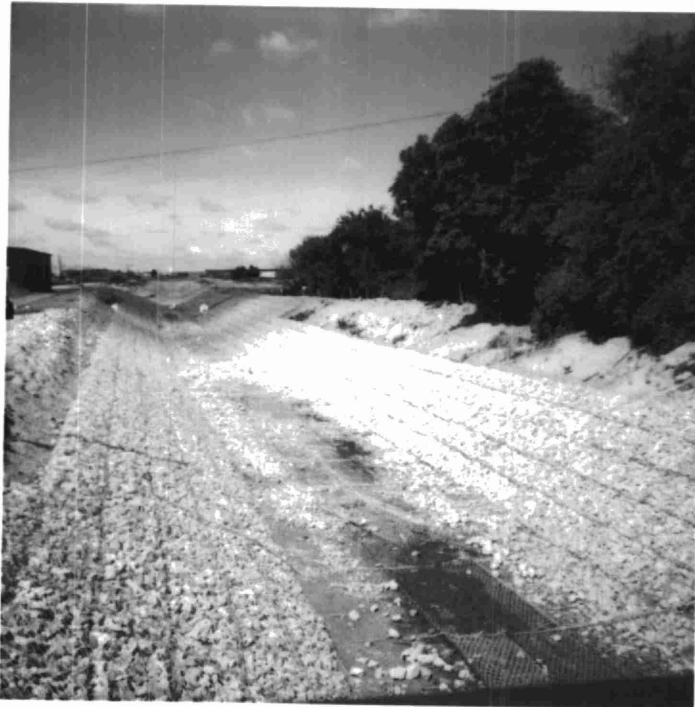
This depicts the bank stabilization work west of Malton by the Metro Toronto and Region Conservation Authority.

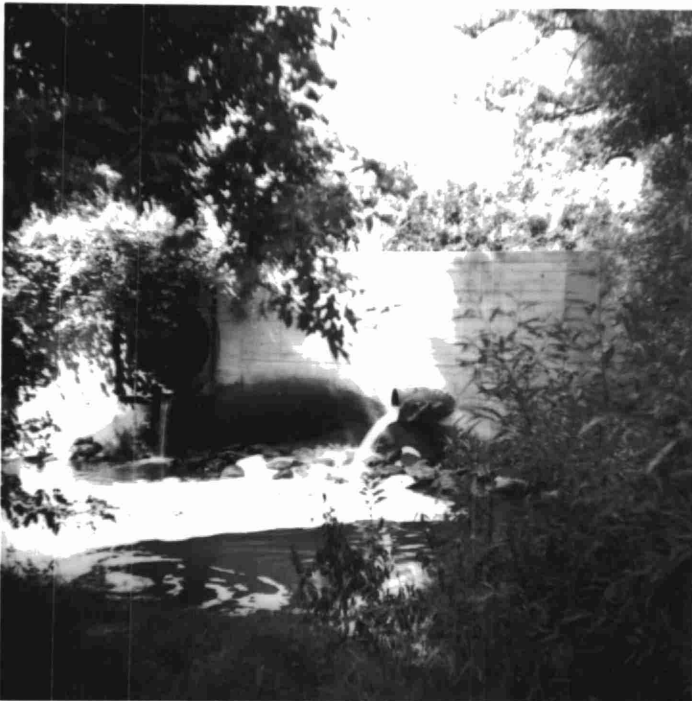
The smaller outfall with the heavy flow is the discharge from the Malton WPCP, south of Derry Road. Note the foaming in the foreground.

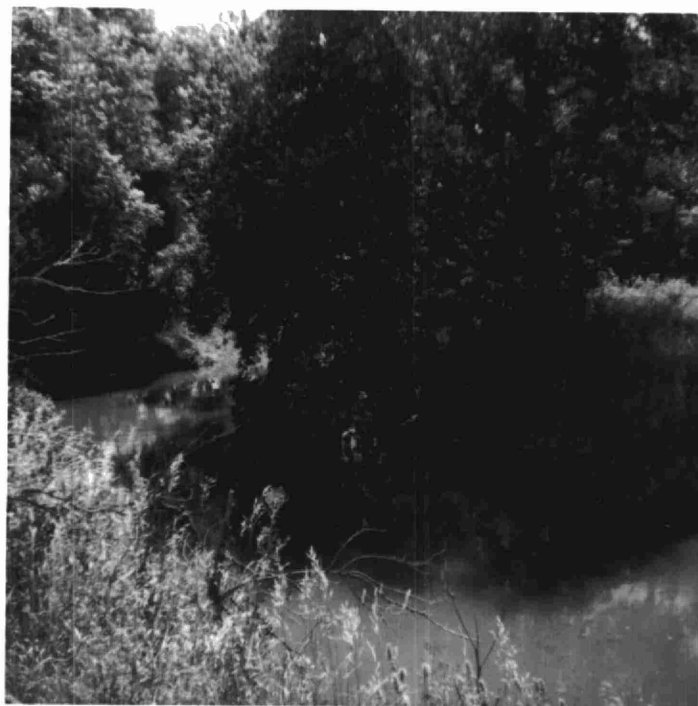
Mimico Creek as seen at the beginning of the survey at Indian Line, looking southwest.

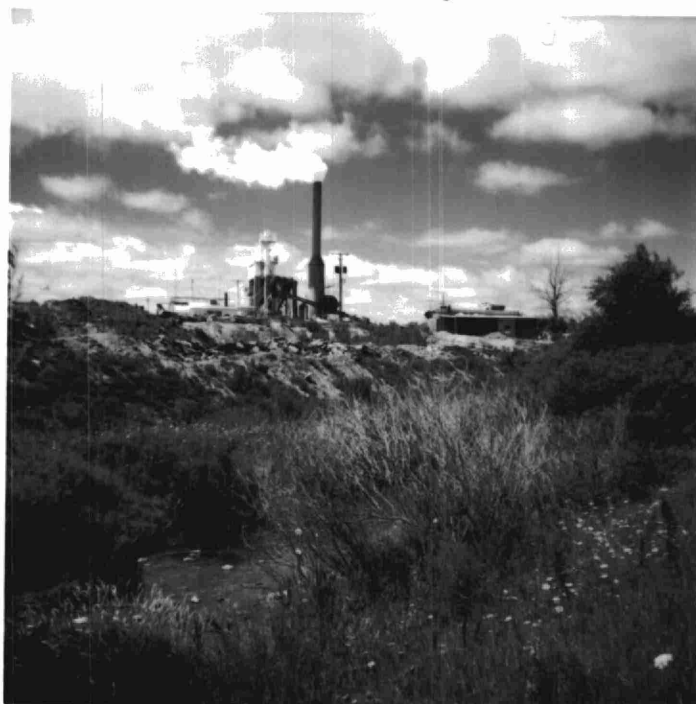
Mimico Creek near Disco Road downstream from Indian Line. The industry observed, Fermar Limited, has a holding pond part way up the bank.

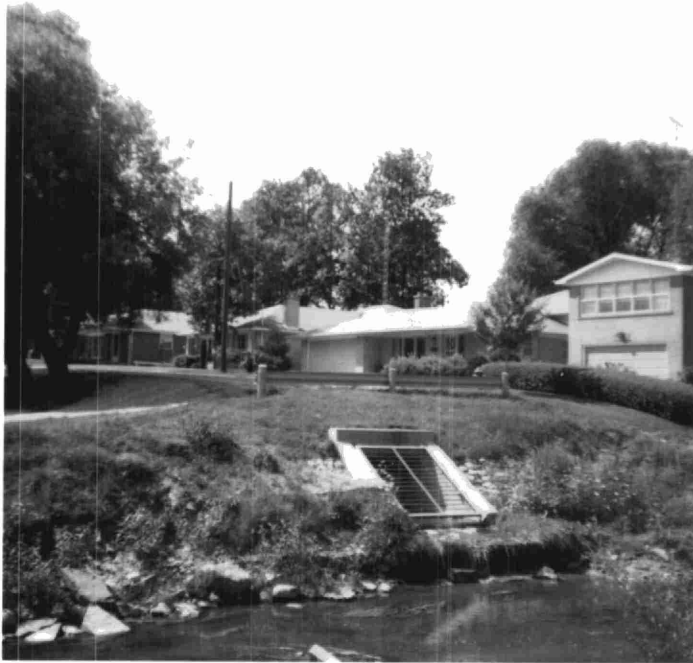
This outfall, MC-75, is located at the end of Springbrook Gardens. It is quite representative of most outfalls found in urban subdivisions.

BOD	1.0 mg/l
SS	0
Total Coliform	3900
Faecal Coliform	1880

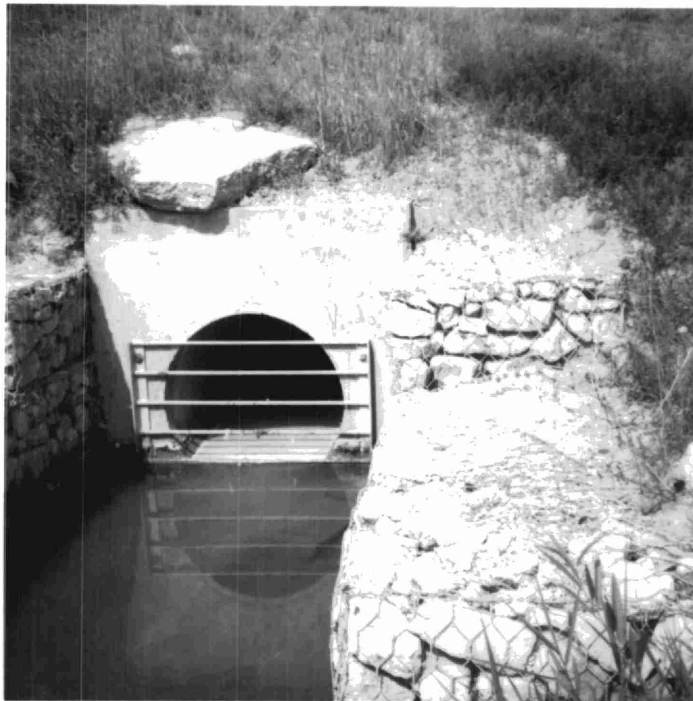
Outfall MC-107 located at the mouth of Mimico Creek south of Lakeshore Road. Note the white scum being discharged which was identified as tallow. It is suspected that industrial wastes are contaminating the effluent of this outfall.

BOD	10 mg/l
SS	15 mg/l
Total Coliform	20,000 to 350,000
Faecal Coliform	3,000 to 70,000

MC-107 (Presence of Tallow).

White scum was
examined by I.R.
Spectrometry and
by hydrolysis.
The scum was
confirmed to be
tallow.

The sewer system that connects to the outfall under consideration should be investigated to discover and remove the cause of the contamination. It is expected that the descriptions and plans included within the report will be sufficient to permit locating of all outfalls.

If industrial wastes should be found to be the cause, the Borough of Etobicoke Sewer Use By-law 402 should be enforced to prevent further contamination entering the watercourse.
